VENDOR FIELD SERVICE BULLETIN
Effective Date: 09/05/2001

Landing/Taxi Light Assembly
P/N: 01-0790131-06 (Right-side Assembly)
P/N: 01-0790131-05 (Left-side Assembly)

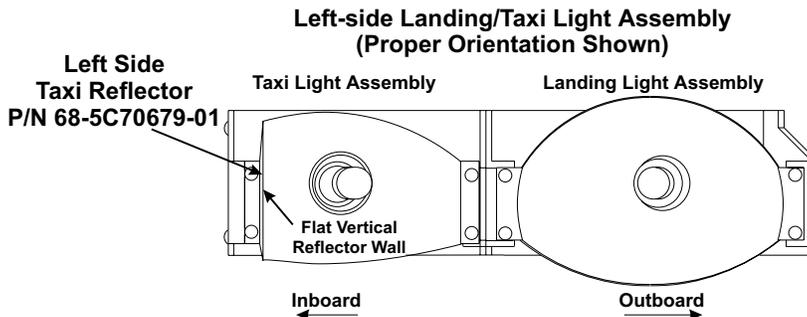
Beginning with the Landing/Taxi light assembly mounted on the Left wing, visually inspect the inboard (Taxi) reflector. Note that this reflector should be oriented as shown, with the flat vertical reflector wall located in the inboard position.

If both the left and right light assemblies are improperly oriented, the taxi reflectors may be removed from their present location and installed on the opposite wing's light assembly. In these cases, no additional reflectors will be needed.

If a single light assembly is improperly oriented, the correct reflector must be installed and the original reflector returned to:

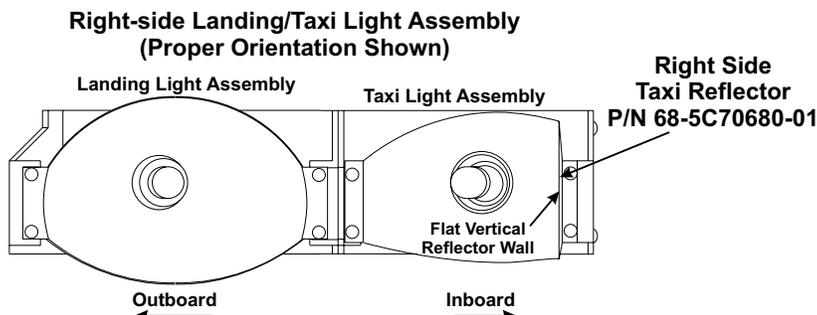
When inspection of the left Landing/Taxi light assembly is completed, proceed to the right Landing/Taxi light assembly. As shown, the flat vertical reflector wall should be oriented so that it is in the inboard position.
