WHELEN[®]

Whelen Preventive Maintenance Notification!

©1996 Whelen Engineering Company.
Form No.13109 (031596)

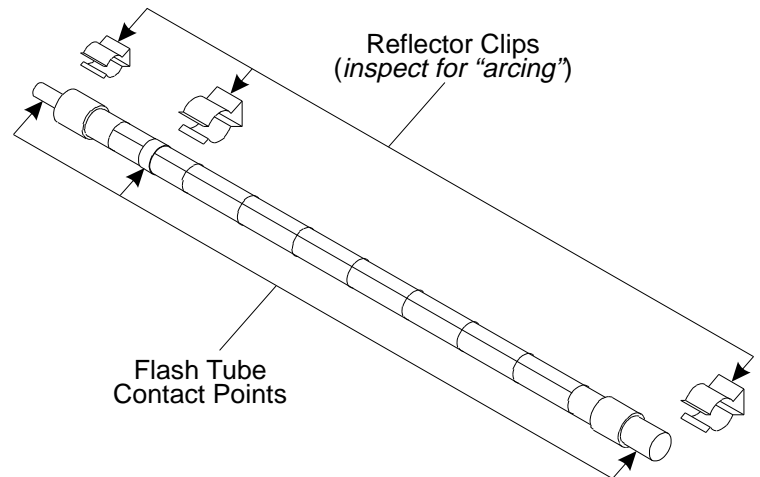
The linear flash tube that you returned for replacement shows signs that the tube has been exposed to high energy arcing. When this condition exists, damage to the tube's contact points and the reflector clips will occur. This type of damage cannot be repaired by the owner and furthermore, will damage any new flash tubes that are installed.

Carefully inspect the reflector clips for ANY indication that arcing has occurred. This is usually represented by small, "scorched" or pitted areas on the clip surface that holds the flash tube in place. If these marks are evident, the reflector must be returned to the factory and replaced.

For "Warranty Claims", return damaged items directly to the factory. See attached warranty statement.

For equipment that is no longer covered by warranty, contact your nearest Whelen distributor for replacements.

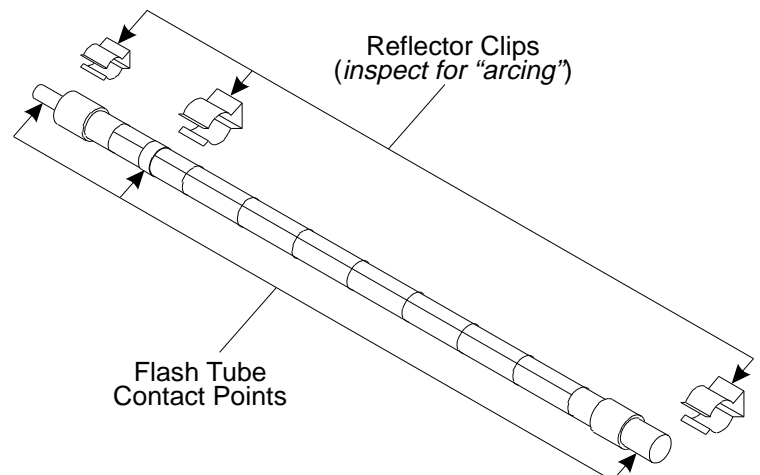
The linear flash tube that you returned for replacement shows signs that the tube has been exposed to high energy arcing. When this condition exists, damage to the tube's contact points and the reflector clips will occur. This type of damage cannot be repaired by the owner and furthermore, will damage any new flash tubes that are installed.

Carefully inspect the reflector clips for ANY indication that arcing has occurred. This is usually represented by small, "scorched" or pitted areas on the clip surface that holds the flash tube in place. If these marks are evident, the reflector must be returned to the factory and replaced.

For "Warranty Claims", return damaged items directly to the factory. See attached warranty statement.

For equipment that is no longer covered by warranty, contact your nearest Whelen distributor for replacements.
